Home Inspection Report

Friday, September 14, 2018

Property Address
755 W Sandpiper
Corolla, NC 27927

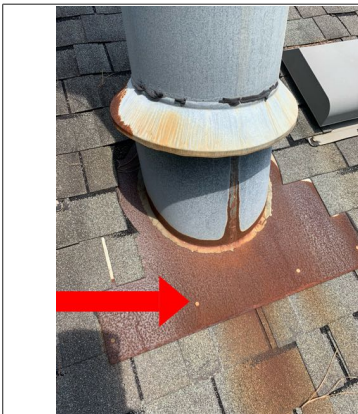
Flashing for the wood burning stove stack is rusted and has exposed fasteners. Recommend roofing professional repair/replace as needed.

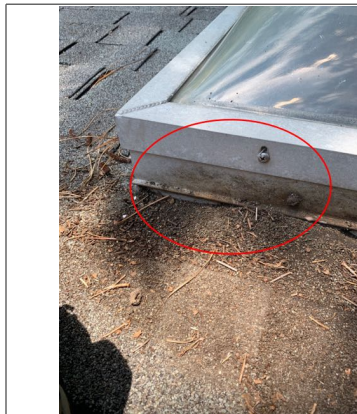
No apron flashing on either of the skylights on the western facing side. Recommend licensed professional repair to prevent moisture intrusion.

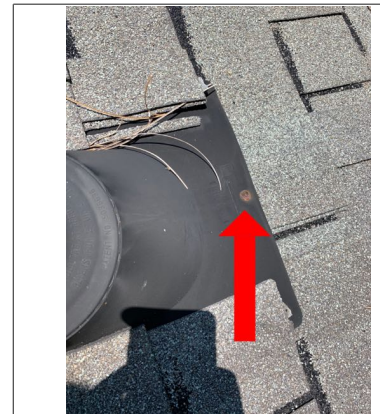
Exposed fastener on the vent stack flashing. Recommend licensed professional repair to prevent moisture intrusion.

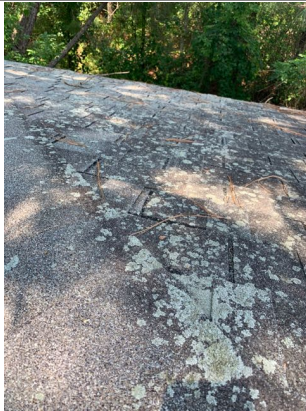
Moss observed on roof covering, recommend licensed professional remove with a mildewcide to extend useful life of roof covering.

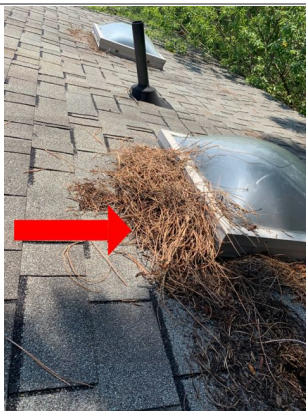
Skylights have a buildup of pine straw, which promotes moisture intrusion. Recommend removing.

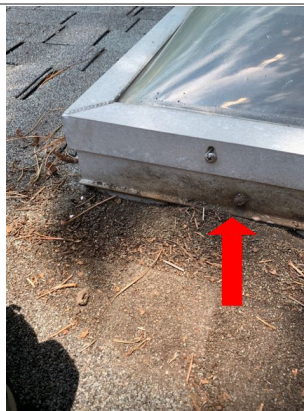
No apron flashing on the top of both western skylights, source for water penetration. Recommend licensed roofer repair.

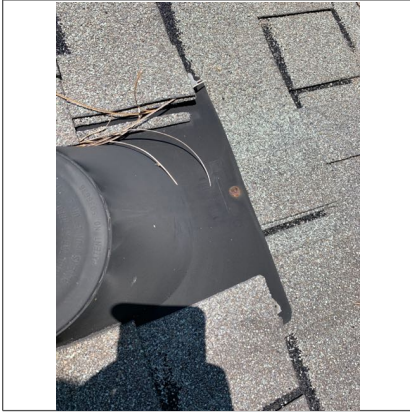
Comments Vent fasteners visible, recommend licensed professional repair to prevent future moisture intrusion

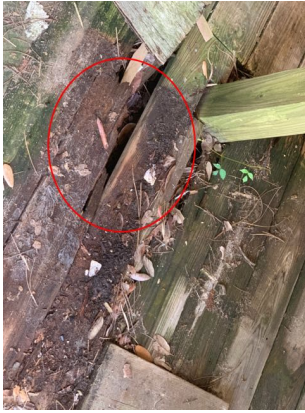
Hole in the baseboards outside lower level sink. Trip hazard, recommend repairing by licensed professional. Additional damage of wood walkway in the same area. Repair professional should reevaluate.

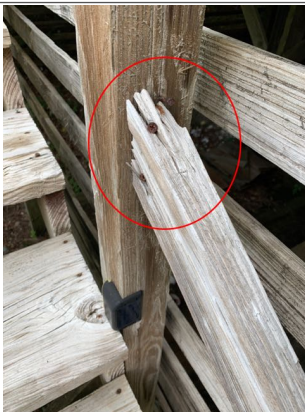
Middle railing on north side of stairs has rotted and needs to be replaced.

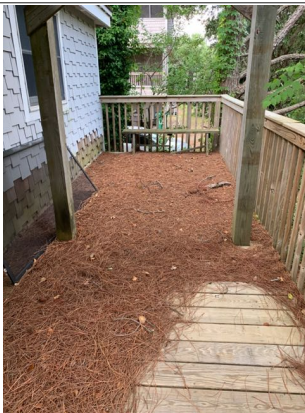
Pine needles are built up on the north side of the deck. Recommend removal to prolong the life expectancy of The deck.

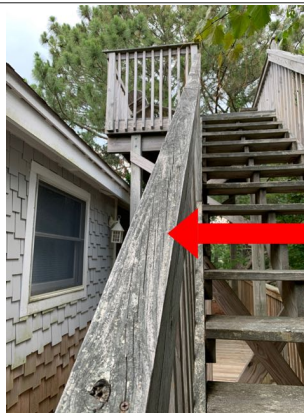
Railing on steps up to top level deck not securely fashioned. Recommend repair professional repair.

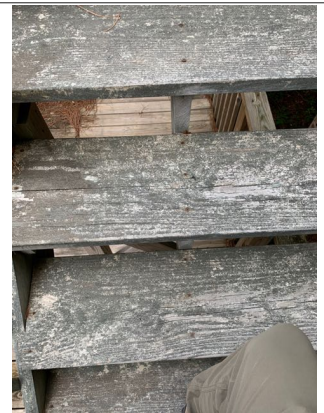
Stair and railings leading to the top level deck have slippery surface buildup. Slip hazard when wet. Recommend having a licensed professional repair/replace.

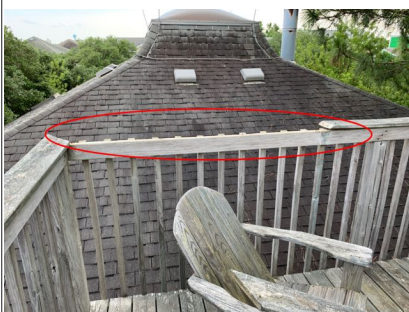
Handrail missing from south side of crows nest. Railings all around the crows nest are also a safety hazard, as they are not properly supported and are loose. Recommend licensed professional repair/replace.

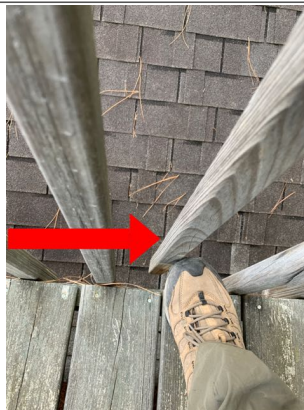
Multiple unfastened balusters around crows nest. Safety hazard. Recommend repair by licensed professional.

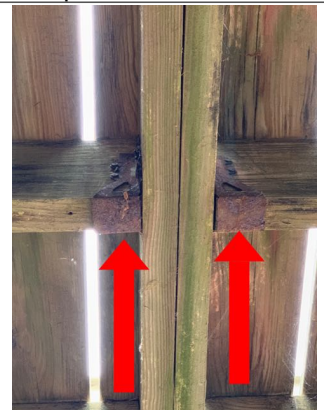
Multiple joist hangers throughout the deck system are rusted, and while still functioning, are past their useful lifespan. Recommend replacing by a deck specialist.

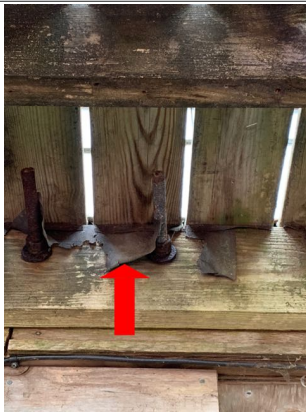
Ledger board flashing has deteriorated. Recommend deck specialist re-evaluate for repairs.

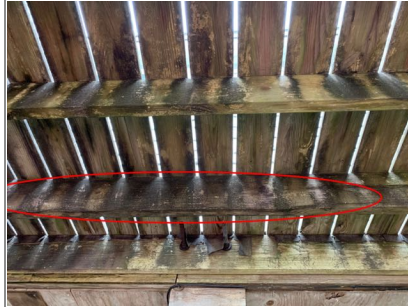
Water damage at one or more joists around especially the south and east facing deck system. No rain diverted system has been installed, which is contributing to the joists decay. Recommend deck specialist re-evaluate.

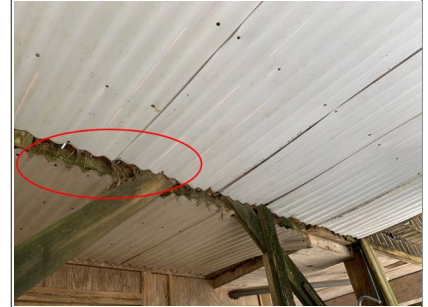
Corrugated pvc installed beneath joists of deck over the outdoor Shower. Excessive buildup of organic material located between pvc and deck, causing breaks in the pvc. It also serves to divert large amounts of water on specific wooden members below, reducing their life expectancy. Recommend repair professional re-evaluate for repair.

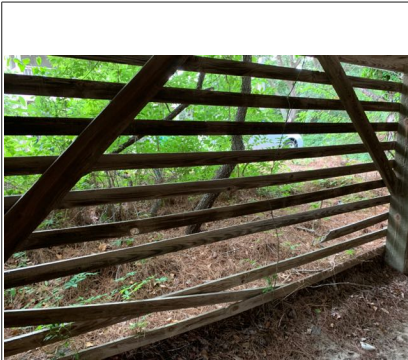
Multiple deck border planks are damaged and/or missing. Many are also in direct contact with the ground, which lessens the useful lifespan.

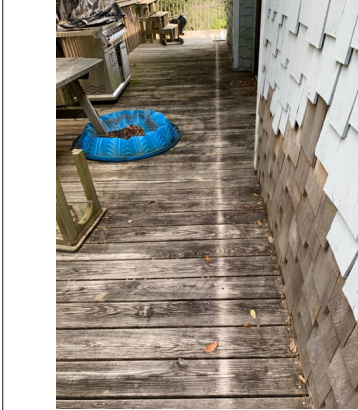
Not having a water diversion system, resulting in staining of the wood and potential cause of damage for the wood siding.

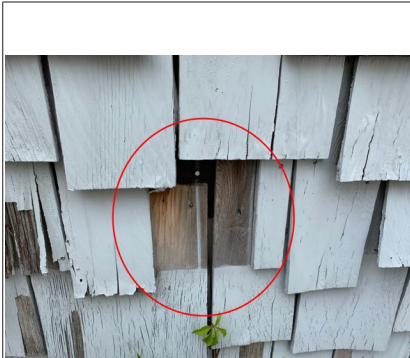
Multiple spots of missing shingles throughout the siding. Recommend siding professional re-evaluate siding.

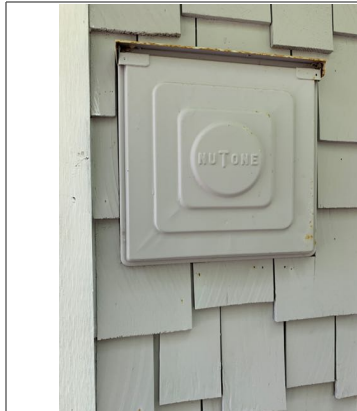
Vacuum port no longer in use.

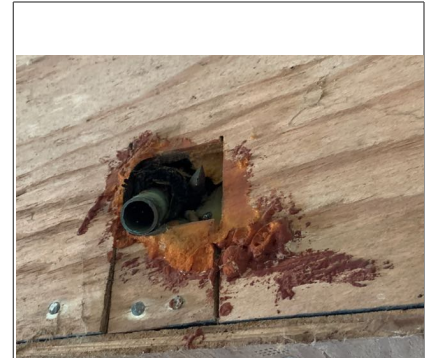
Open entry spot into the storage room, on the western side of the carport siding. Recommend repair professional repair to restrict animals from possible entry.

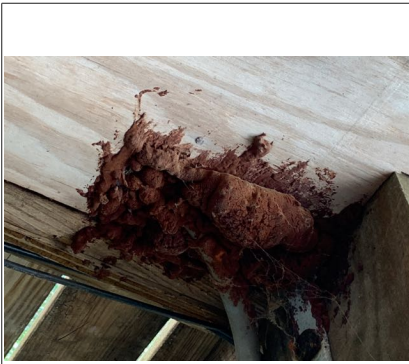
Multiple spots of foam sealant that is passed its useful lifespan. Recommend licensed professional repair/replace as needed throughout the underside of the home.

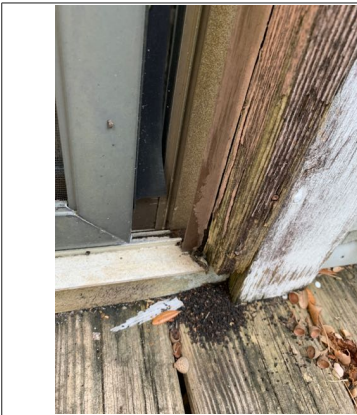
Trim around west facing slider door damaged, refined. Repair/replace by a licensed professional.

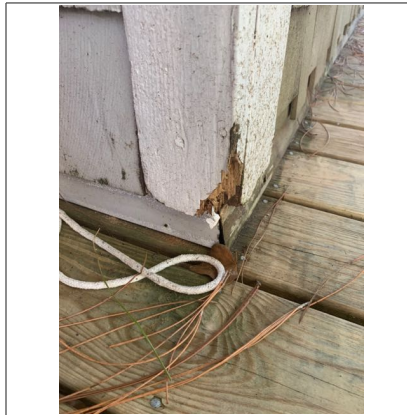
Damage at the base of multiple pieces of trim throughout the exterior. Recommend repair professional repair as needed

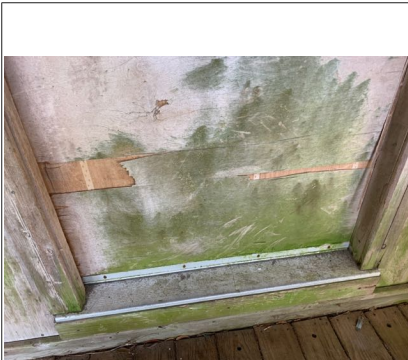
Storage room door is delaminating and showing signs of moisture staining organism. Recommend repair professional re-evaluate.

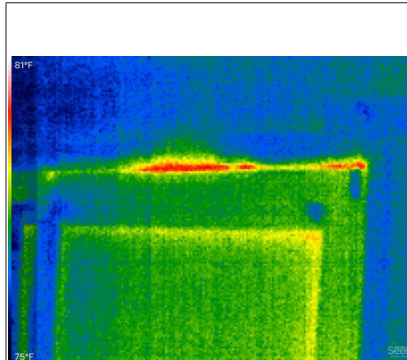
Damaged weatherstripping at the top of the front door. Recommend repair by a licensed professional to ensure efficiency of the building envelope.

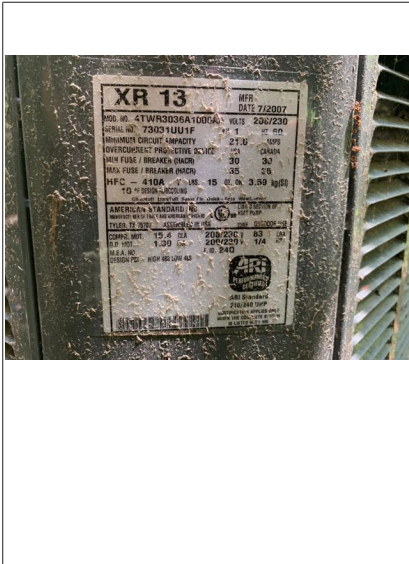
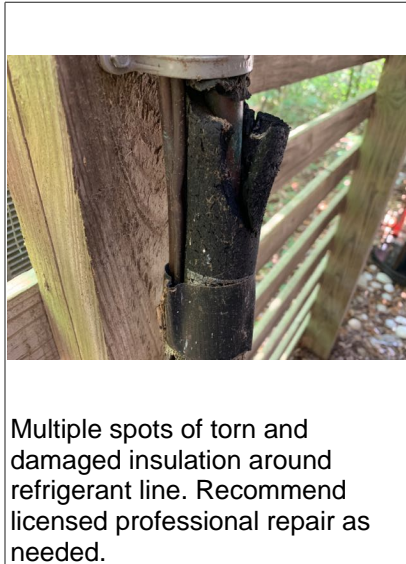
Comments Outside condenser unit coils dirty recommend cleaning.

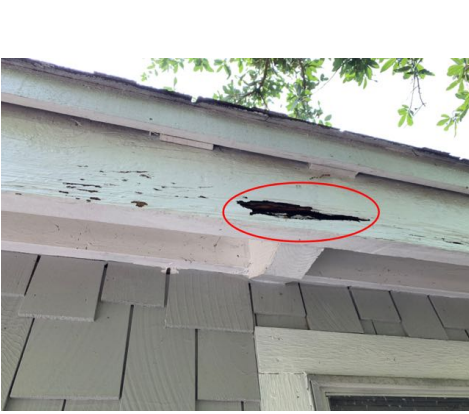
Fascia board damage at E side of the house. Recommend licensed professional repair/replace as needed.

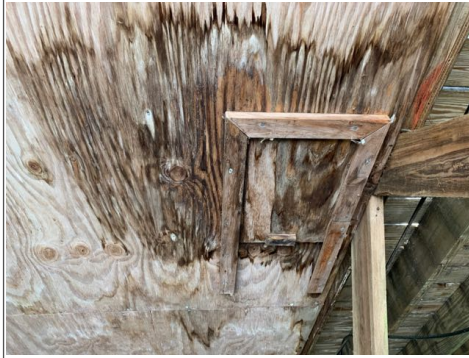
Active moisture location detected at the southern end of the carport ceiling. There is an access to this exact spot cut out of the ceiling, suggesting prior issues in this area. Recommend licensed repair professional re-evaluate.

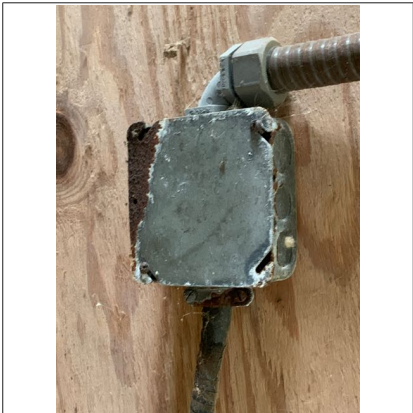
Rusted junction box at underside of carport ceiling, recommend licensed electrician replace.

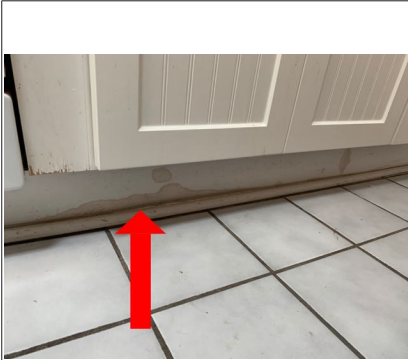
Underneath the sink and around the southern edge on the base of the cabinets, there is water staining that doesn't currently have any moisture. Unable to determine what was the original cause.

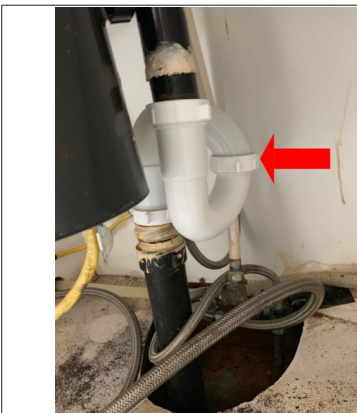
S trap is being used at the kitchen sink. Known to be problematic. Recommend plumber replace.

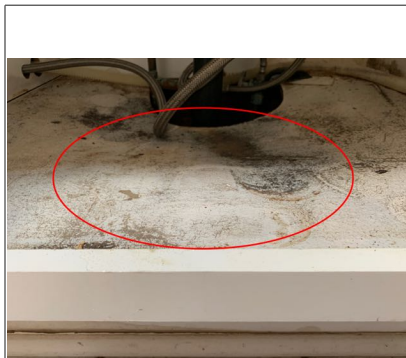
Staining observed underneath the sink base floor. Water drainage tested and no evidence of an active leak at this time. Also no moisture observed on the floor.

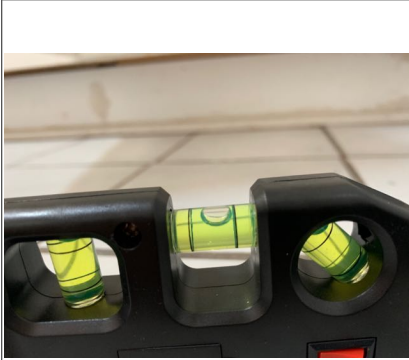
Floor is sloping towards the SE corner of the kitchen. Unable to determine cause, however there was dry water staining in the corner behind the refrigerator. Recommend licensed professional re-evaluate.

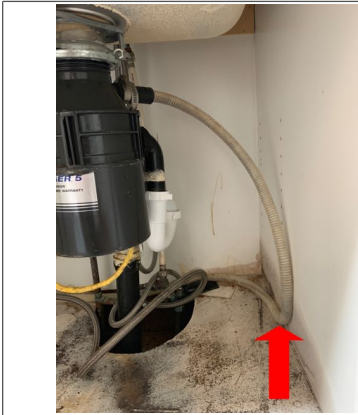
Drain line is not looped,
recommend repair by licensed
professional to prevent cross
contamination from sink to the
dishwasher.

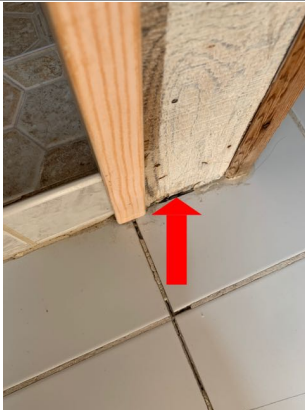
Caulk/grouting needed to prevent moisture intrusion. Recommend licensed professional repair/replace.

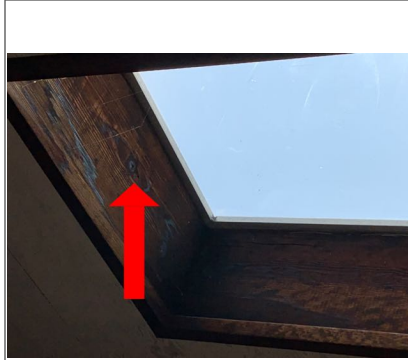
Water damage at wood trim around skylight. Active water detected within wood. This coincides with the lack of apron flashing observed on the roof around the skylight. Recommend licensed roofer repair.

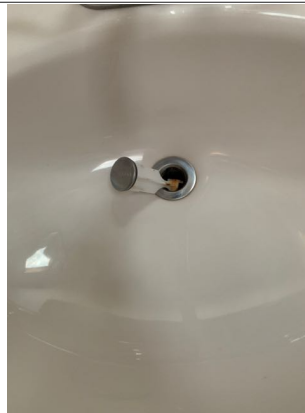
Stopper does not operate in the sink. Recommend repair by licensed professional.

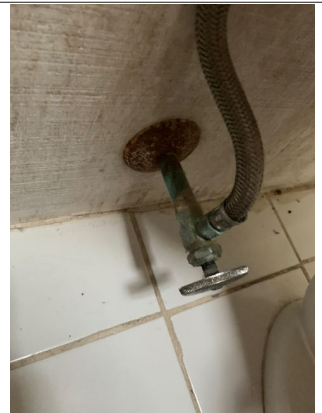
Corrosion at the water supply piping for the toilet. Recommend licensed professional repair/replace as needed.

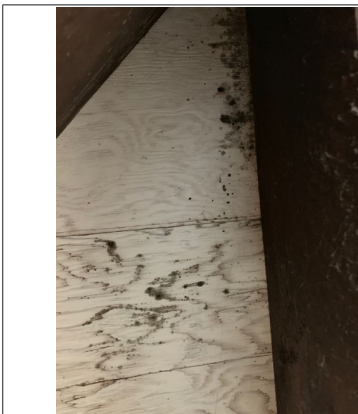
Organic growth observed on ceiling between beams. Recommend licensed professional re-evaluate.

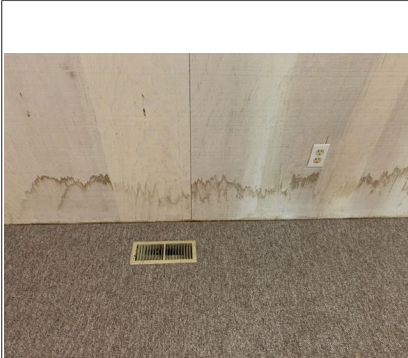
Water staining observed. Not currently holding any moisture at this time. Recommend monitoring, as siding at that spot on the exterior siding has recently been replaced.

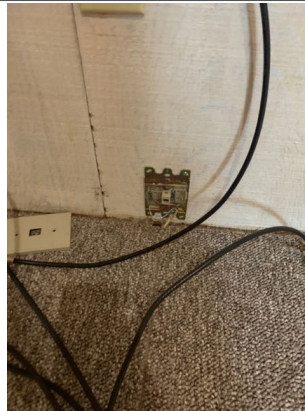
Missing cover plate for Ethernet cable jack. Safety hazard, recommend repair by licensed electrician.

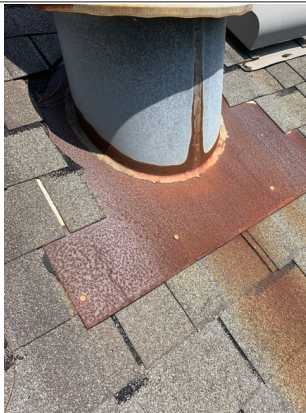
Exhaust stack has rusting throughout. Recommend licensed roofer re-evaluate.

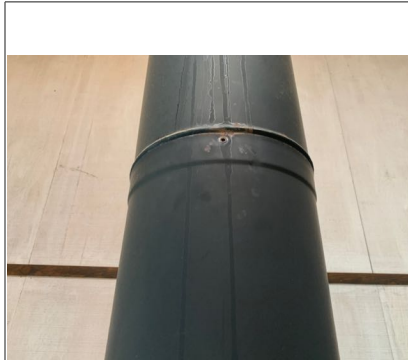
Wood burning stove exhaust is not properly attached, missing screws to attach each segment of pipe. Safety hazard. Recommend licensed professional repair/replace as needed.

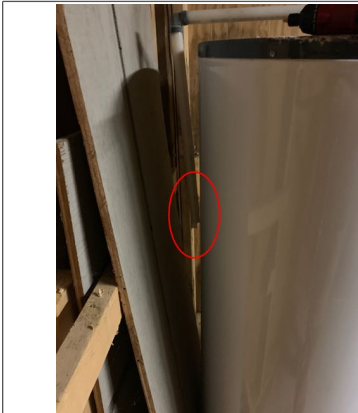
Temperature pressure relief valve doesn't terminate within 4" of the ground. Recommend plumber repair.

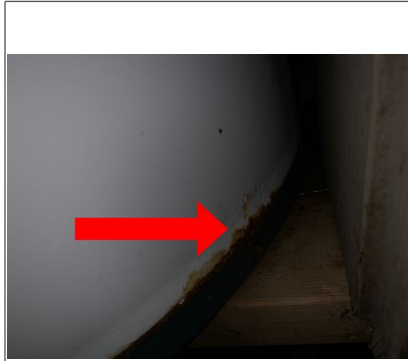
Rusting at the base of the water heater. Have plumber re-evaluate before closing agreement.

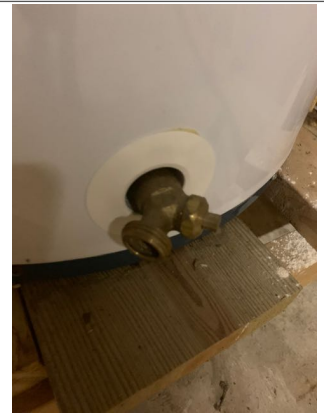
No handle for operating the discharge valve. Recommend plumber repair.

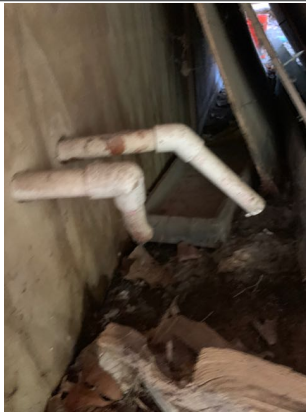
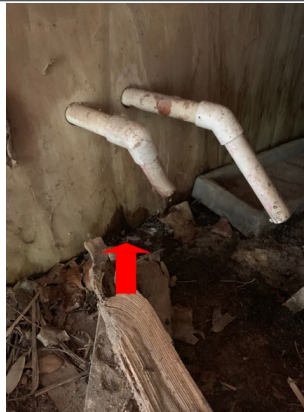
Condensate drain line is discharging too close to the house, causing damage to the siding of the north side of the storage room exterior. Recommend plumber repair.

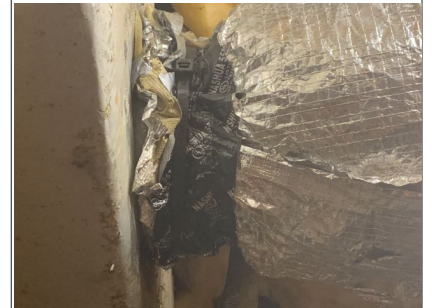
Improperly sealed flex duct connection. Recommend licensed professional repair to achieve intended efficiency.

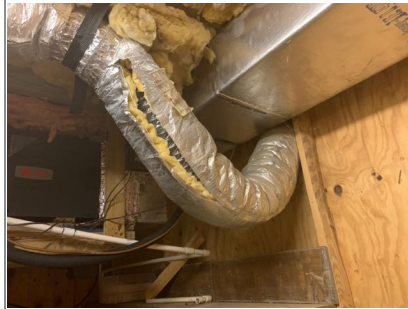
Flex duct is crimped in multiple places throughout the storage room area. This restricts airflow and increases air friction. Recommend licensed professional re-evaluate and repair as needed for the visible flex duct in the storage room area.

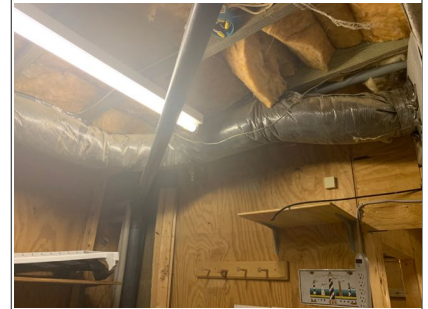
Not properly supported flex duct work. flex duct should be secured every 4ft, and without having an extreme or bent direction. This flex duct is not supported within 4ft, and bends at an angle that restricts airflow. Recommend licensed professional repair as needed.

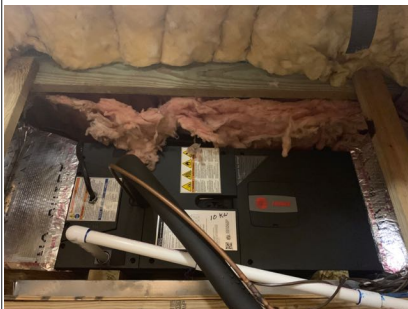
Insulation has fallen from multiple areas throughout the storage room ceiling. Recommend repair to

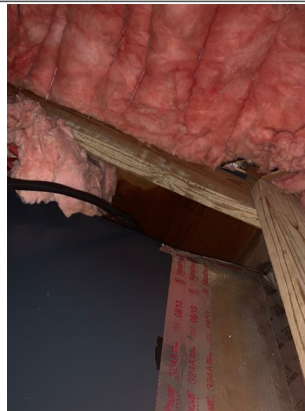
Missing insulation around the air handler, recommend licensed professional repair.

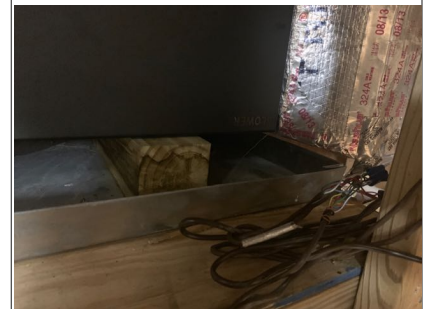
Exposed wires in front of the air handler. Safety hazard, recommend licensed electrician put in a junction box.

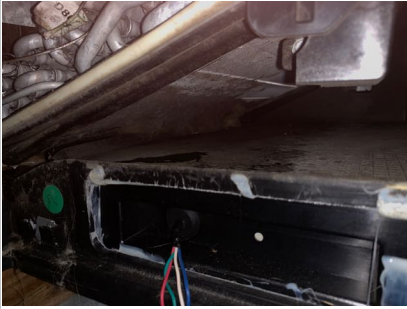
Evaporator cool fins have a buildup of debris. Recommend licensed HVAC professional clean to ensure system runs as intended.

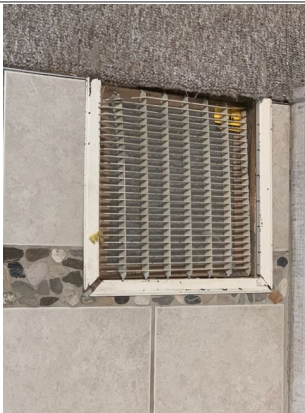
Cracked register on the southern side of the living room.

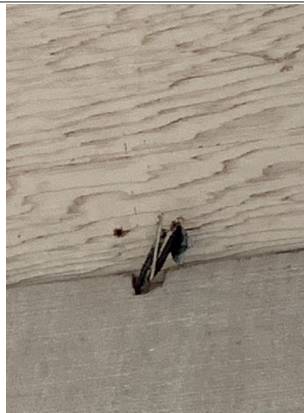
Exposed wiring at the southern wall above the main door. Recommend licensed electrician repair.

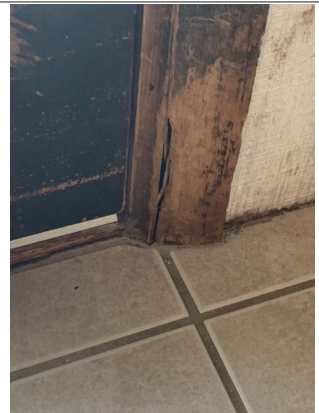
Damaged wood trim around the front door. Recommend repair as needed.

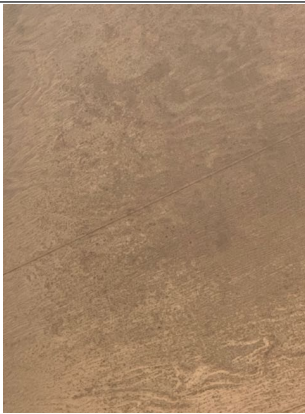
Organic growth around the skylight. Recommend a licensed specialist re-evaluate.

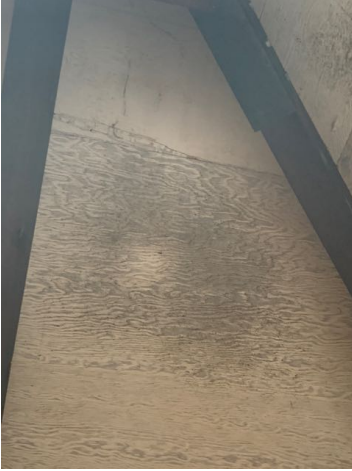
Organic growth around the skylight.
Recommend licensed professional
re-evaluate.

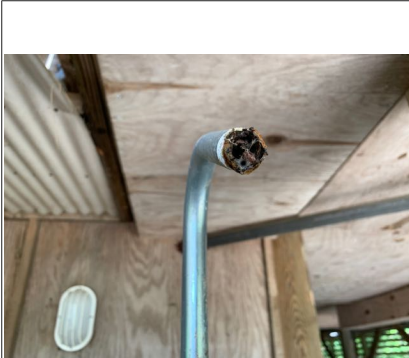
Missing shower head.
Recommend replacing for
intended proper usage.

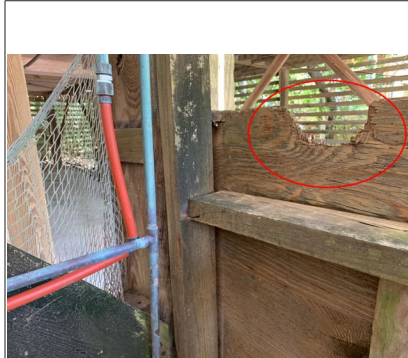
Damage to wood siding around
the shower area. Recommend
replacing for proper intended use.

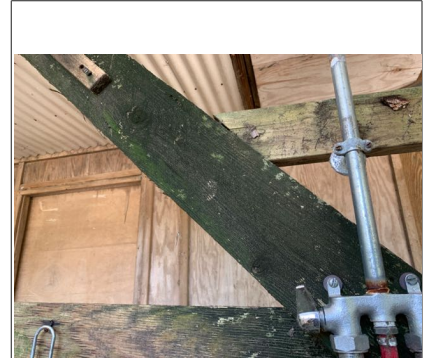
Harmful organic growth at
multiple spots on the interior of
the of the shower enclosure.
Recommend repair/replace as
needed by a licensed
professional.
