Home Inspection Report

Friday, September 14, 2018

Property Address
755 W Sandpiper
Corolla, NC 27927

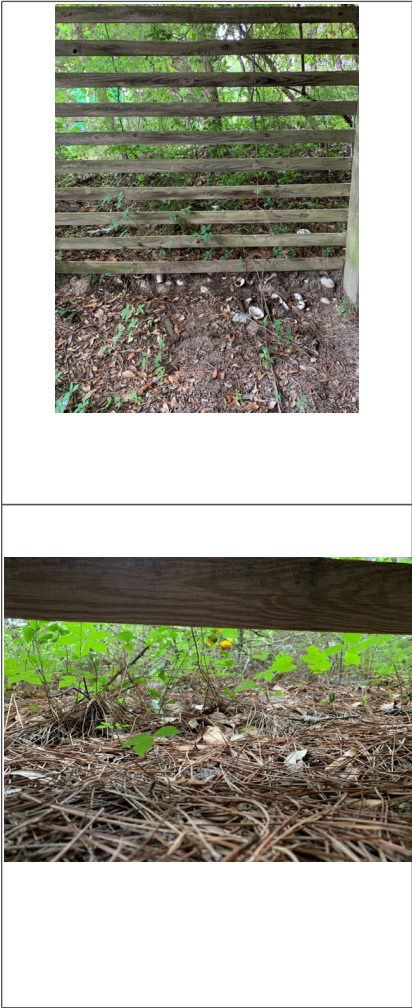
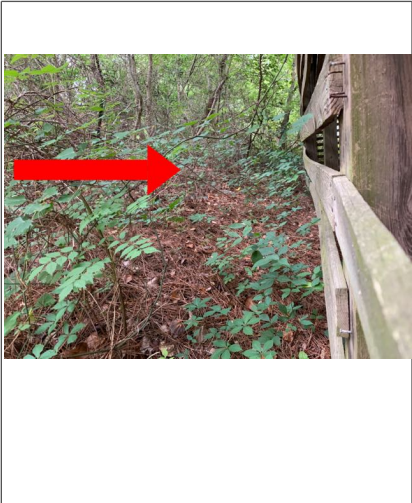
Landscaping affecting foundation

Negative Grade ☒ West ☒ North ☒ Trim back trees/shrubberies
